Fire Damage Remediation Protocol

REPORT DATE:	November 28, 2018
CLIENT:	George Hills & Company Insurance Attn: Cameron Dewey; Claims Manager 530-276-5322 cameron.dewey@georgehills.com Claim No. WFIA-0159A9
JOB SITE ADDRESS:	Sierra House Elementary School 1709 Remington Trail South Lake Tahoe, CA 96150

Subject: Fire Damage Remediation Report & Protocol
Sierra House Elementary School
1709 Remington Trail
South Lake Tahoe, CA 96150

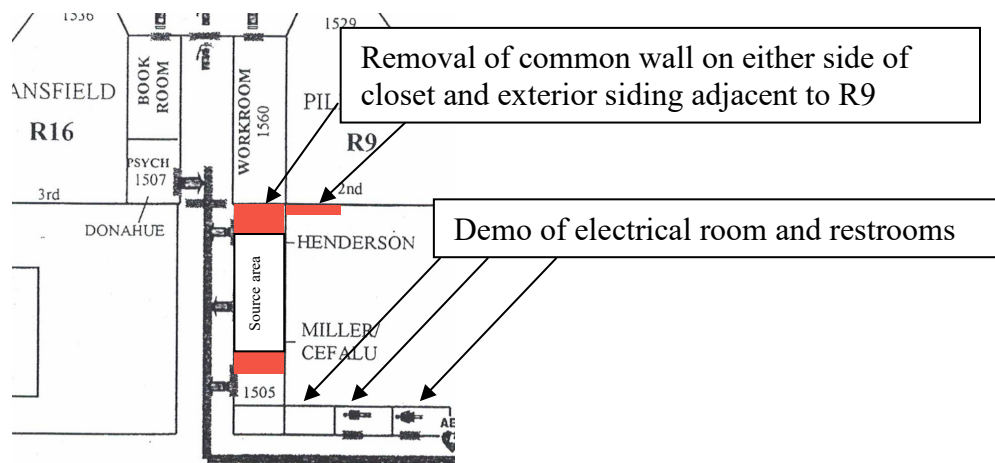
Demolition – The walls, ceiling and flooring materials within the source room where the fire originated have been removed. According to Servpro, they performed sand blasting of the ceiling material to remove the heavy char. The common wall where the fire originated contains a plywood sheer wall with insulation still inside (see picture below). On the adjacent wall is a storage closet with built in cabinets. It was explained that this area and wall was extinguished using water by the fire department and may still contain moisture. Based on this condition, we are recommending the removal of the cabinets, drywall, insulation and drywall/sheer wall from floor to ceiling (see figure below). The sheer wall is considered to be a structural item and any removal should be verified and confirmed by an architect, engineer or other professional.

Source of electrical fire; common wall

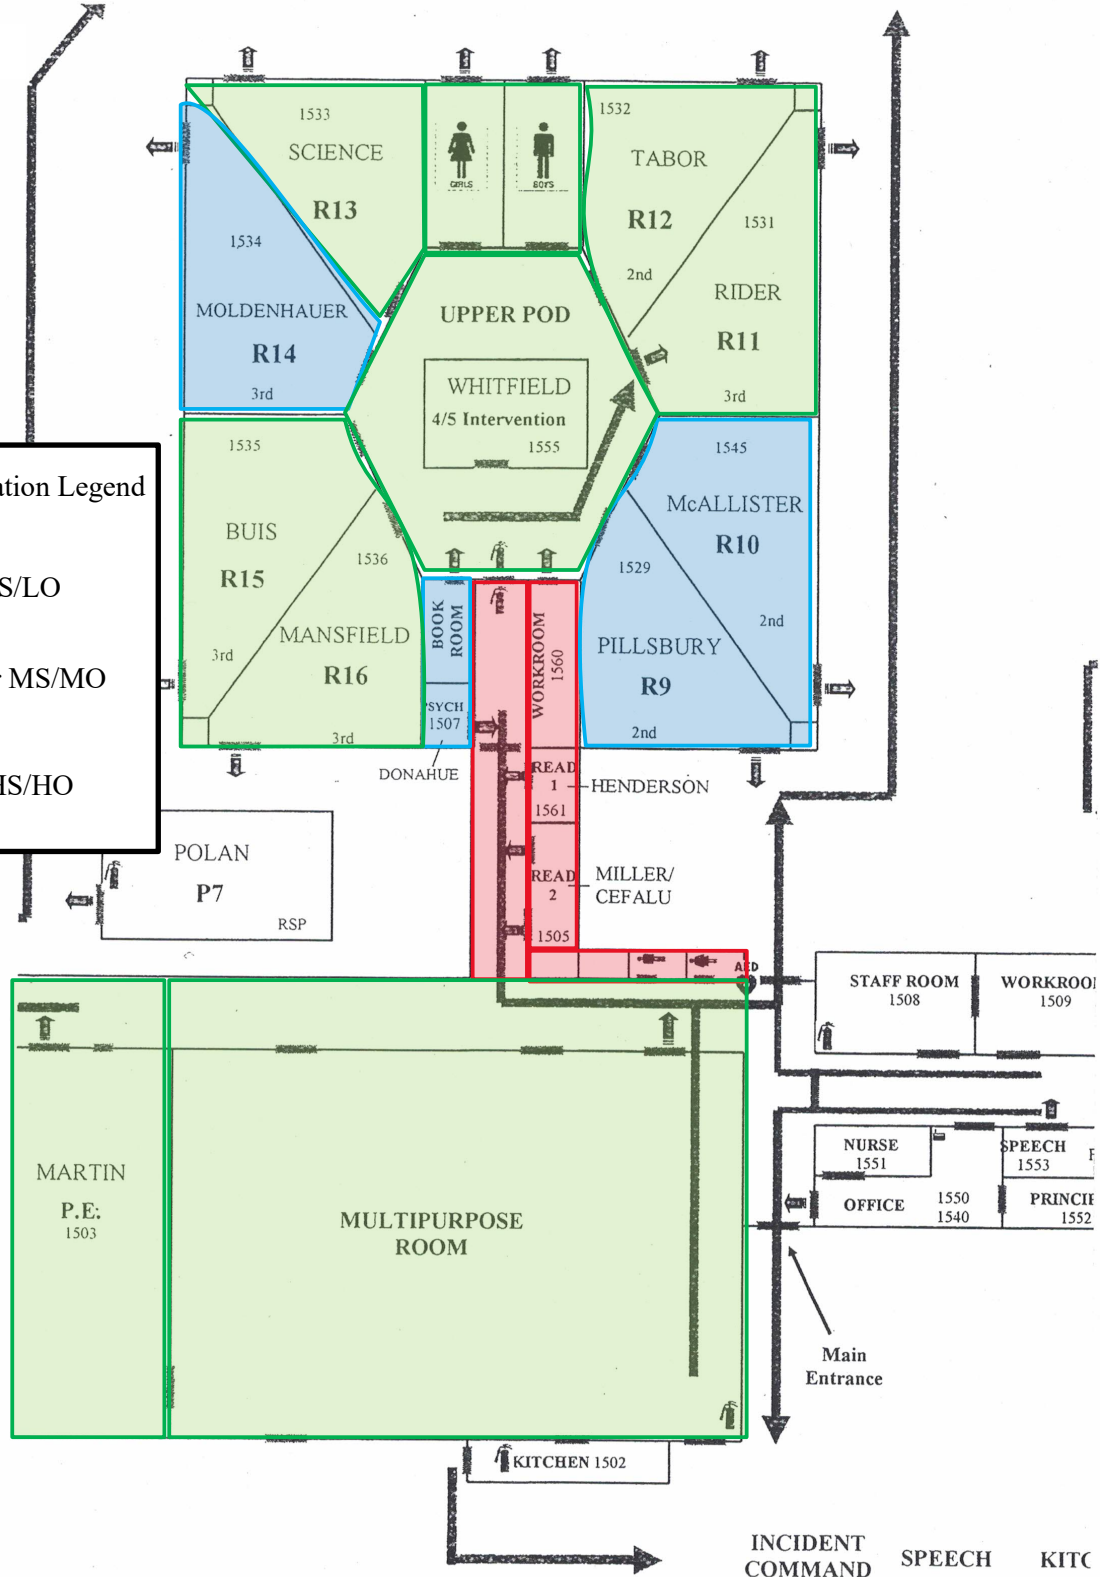
Soot/Ash/Char Assessment – The evaluation of the site conditions was broken up into classifications based on our professional judgement and level of cleanliness (See Table 1). The 3 classifications are Light Soot/Odor, Moderate Soot/Odor and Heavy Soot/Odor which are also color coded accordingly. The objective of this assessment was to determine the specific cleaning protocols for each area. See the Figure 1 showing the different rooms and their classification.

Light Soot/Odor Cleaning Protocol	
Light Soot/Odor (LS/LO)	<u>Porous Items (horizontal and vertical)</u> <ul style="list-style-type: none"> • Ceiling tiles (12"x12" and 2'x4') & fiberglass insulation – Restoration of these items may be difficult due to their porosity and may not be financially feasible. Attempts to restore can be made using air washing techniques and/or HEPA vacuuming, however removal and replacement should be considered. Ceiling metal grid systems can be air washed (depending on how sticky) and/or wiped down using a mild alkaline detergent. • Books/other porous school items – HEPA Vacuuming and/or air washing within containment. Hard cover books and items and be wiped down using a mild alkaline detergent or similar. • Carpet & bullpen walls, porous bulletin boards – HEPA vacuuming of vertical surfaces. Carpets should be HEPA vacuumed followed by professional carpet cleaning. Cleaning & restoration costs for carpet should be compared to replacement to determine most feasible option.

Medium Soot/Odor Cleaning Protocol	
Medium Soot/Odor (MS/MO)	<p><u>Porous Items (horizontal and vertical)</u></p> <ul style="list-style-type: none"> • Ceiling tiles (12"x12" and 2'x4') & fiberglass insulation – Recommend removal and replacement due to the porosity and difficulty of cleaning. Ceiling metal grid systems can be air washed and/or wiped down using a mild alkaline detergent. • Books/upholstery or similar school items – HEPA vacuuming and/or air washing within containment. Hard cover books and items can be wiped down using a mild alkaline detergent or similar product compatible with the item. • Carpet & bullpen walls, porous bulletin boards – HEPA vacuuming of vertical surfaces. Carpets should be HEPA vacuumed followed by professional carpet cleaning. Cleaning & restoration costs for carpet should be compared to replacement to determine most feasible option. <p><u>Semi Porous Items (horizontal & vertical surfaces)</u></p> <ul style="list-style-type: none"> • Wood paneling, etc. – Cleaning using a mild alkaline detergent (less than 10 pH) or similar. May include using dry cleaning sponges or towels. <p><u>Non Porous Items (horizontal & vertical surfaces)</u></p> <ul style="list-style-type: none"> • Metal, glass, plastic, etc. – Cleaning using a mild alkaline detergent (less than 10 pH) or similar. May include using dry cleaning sponges or towels. In hard to reach locations, air washing may be used to dislodge particulates in interstitial spaces. <p>Note: Be careful of incompatibility of cleaning agents and surfaces</p> <p>HVAC – If mechanical HVAC components are restorable, disassemble and clean using a combination of HEPA vacuuming, mechanical cleaning using brushes or whips. HVAC modification and cleaning should be done in accordance with NADCA standards. All filters should be replaced after thorough cleaning. HEPA equipment using "push – pull" system should be considered during the cleaning to remove airborne particles. All components of the system should be evaluated and cleaned as necessary including registers, ductwork, plenums, boots, coils, motors, etc.</p>

Heavy Soot/Odor Cleaning Protocol	
Heavy Soot/Odor (MS/MO)	<u>Porous Items (horizontal and vertical)</u> <ul style="list-style-type: none"> • Ceiling tiles (12"x12" and 2'x4') & fiberglass insulation – Recommend removal and replacement due to the porosity and difficulty of cleaning. Ceiling metal grid systems can be air washed and/or wiped down using a mild alkaline detergent. All light fixtures (mainly attic side), metal beams, wiring/cables should be thoroughly cleaned. • Books/upholstery or similar school items – HEPA vacuuming and/or air washing within containment. Hard cover books and items can be wiped down using a mild alkaline detergent or similar product compatible with the item. • Carpet & bullpen walls, porous bulletin boards – Recommend removal and replacement due to the porosity and difficulty of cleaning. Any cleanable porous item may also need to be professionally cleaned, depending on the severity.

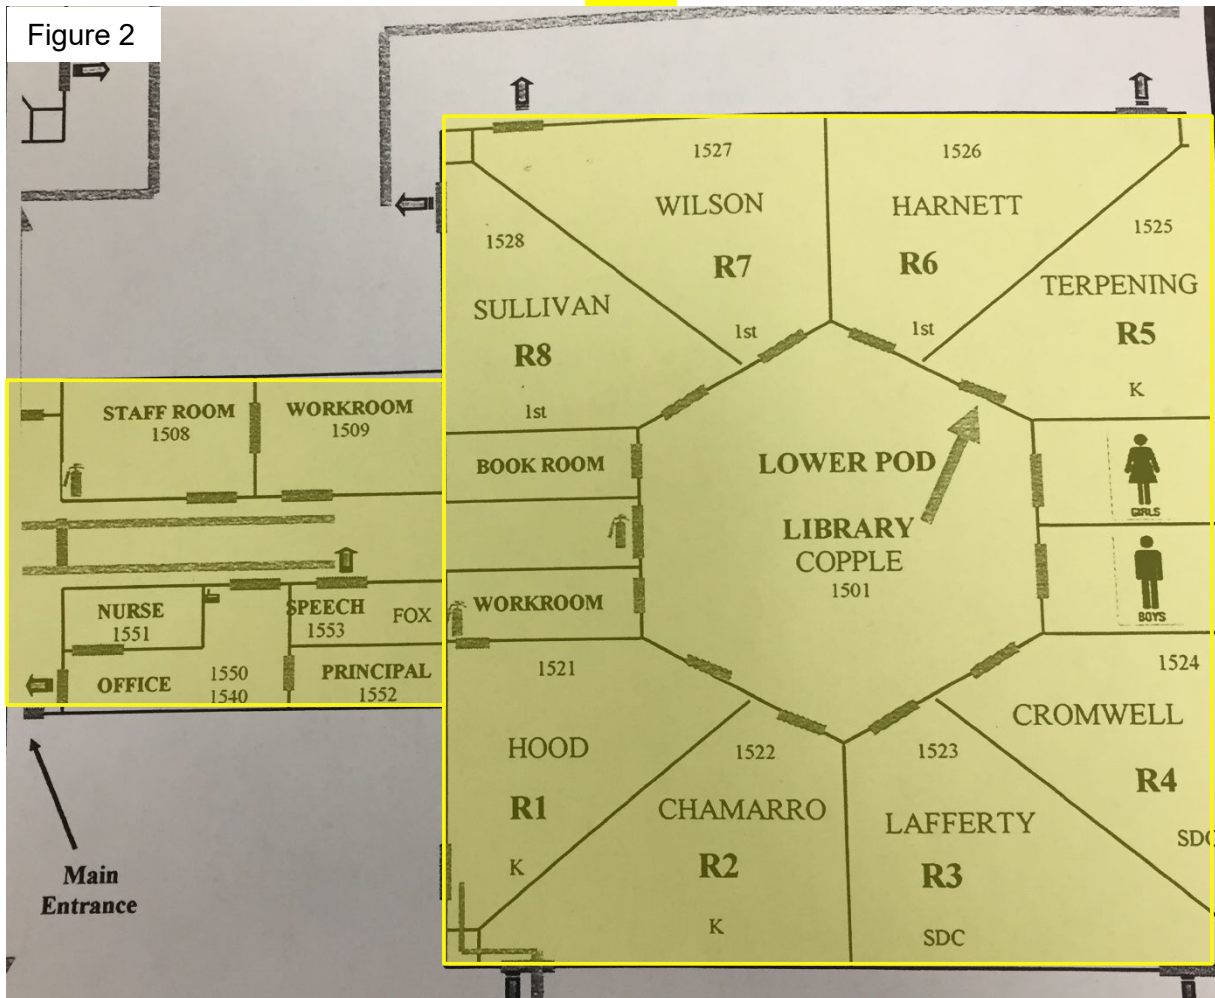
Figure 2

Lower Pod, Office area, Rooms P1-7 – These areas of the school did not reveal any visual evidence of combustion by-products, however, PEC is recommending air scrubbing be performed in each room for a minimum of 4hrs using HEPA filtration equipment as a precautionary measure only (See Figure 2). The purpose is to remove any airborne particles that may have drifted into these areas during the initial restoration process.

Precautionary Air scrubbing

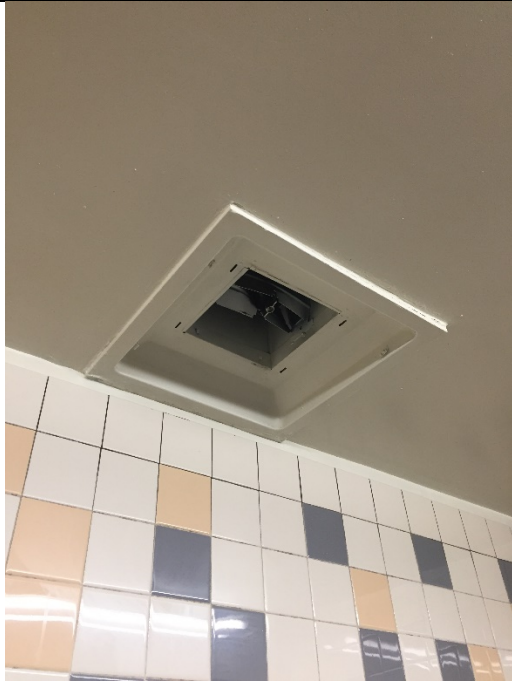
Restrooms and electrical room across from Multipurpose – Heavy odor was observed within these rooms during our assessment. It appears the HVAC duct work that came from the source room was connected to the restrooms. According to Servpro, the ductwork was severed inside the source room in order to isolate the restrooms, however it did not appear any cleaning of the interior of the ducts were performed. The ceilings in each restroom were painted with a sealer in hopes to lock down the smoke odor, however the odor was still considered heavy. It is likely that the odor is trapped within the drywall paint and sealer and likely inside the walls, which may have insulation inside. Our recommendation is to remove the remainder of the ductwork that goes to the restrooms (all work related to HVAC systems should be performed in accordance with National Air Duct Cleaning Association or NADCA standards). Demolition of the ceiling and exterior outer walls in each restroom should be performed to determine the extent of smoke damage within these cavity spaces. Depending on the extent and type of building materials within these restrooms, full demolition of all walls may be warranted in order to clean and deodorize.

Hallway bathroom HVAC vent w/ Heavy odor.

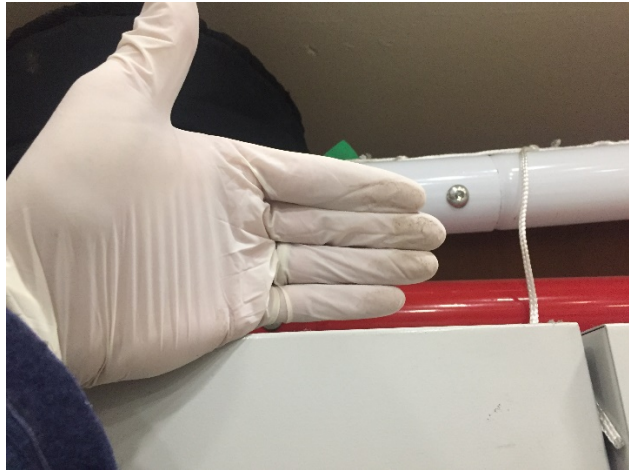
Light residual particulate found inside of multi-purpose room

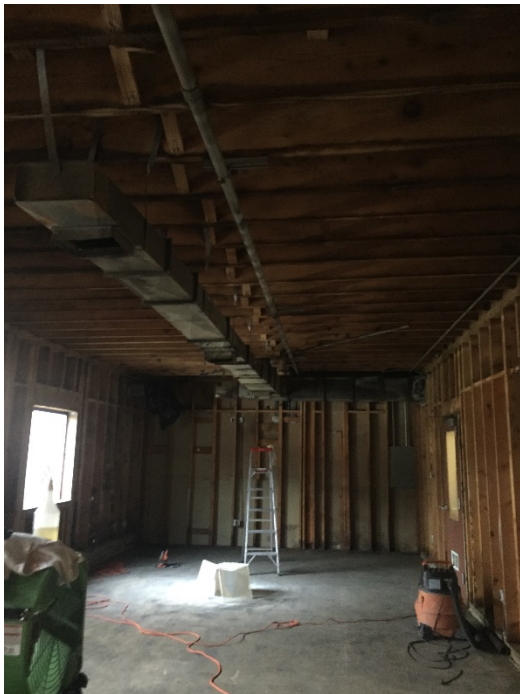
Fire origination (source room)

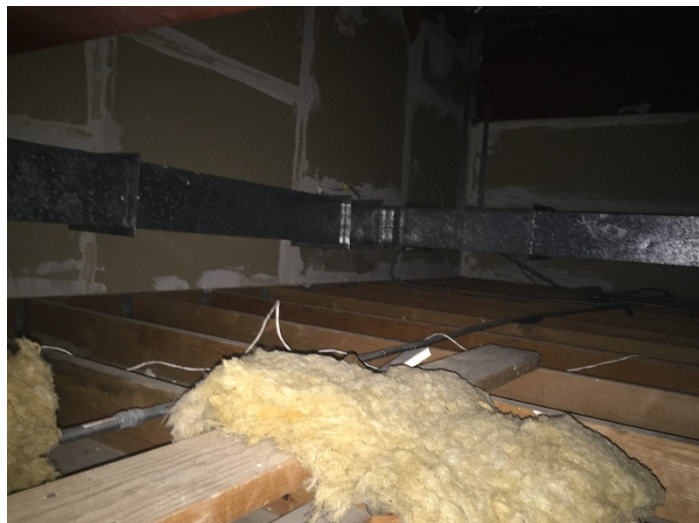
Attic space showing fiberglass insulation.

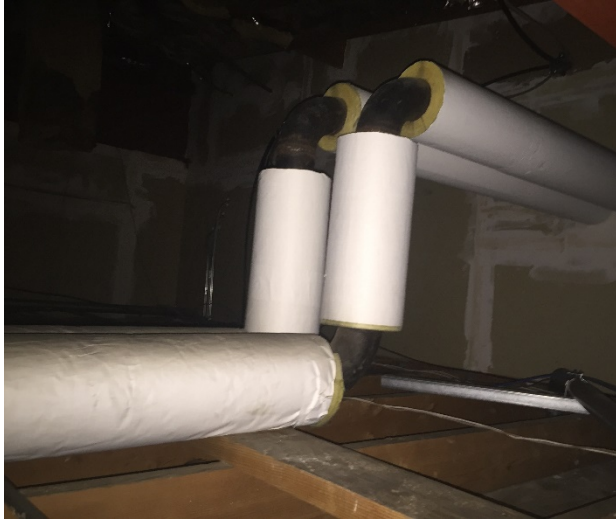
Insulation wrap with exposed insulation

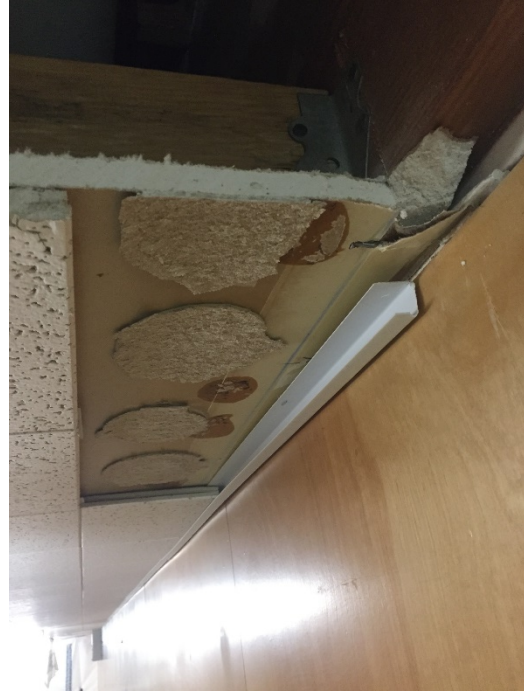
Ceiling tiles in source hallway

Source Hallway – The ceiling lid and the wood paneling walls will need to be removed to access the wall behind for cleaning and deodorization. In an attempt to minimize demolition, start with the

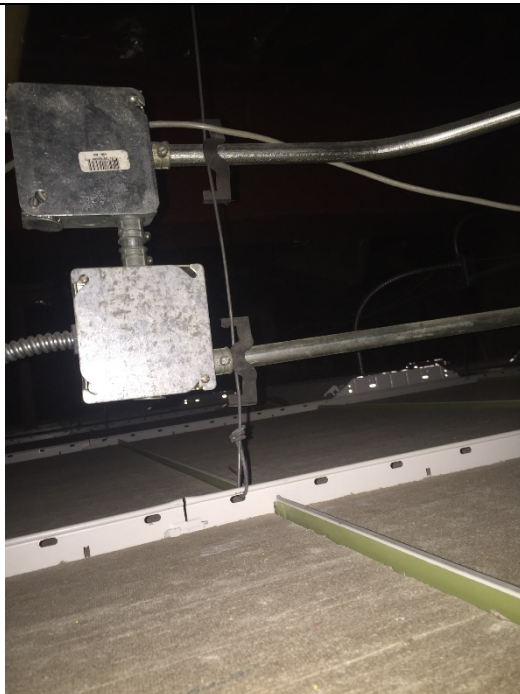
Condition in attic showing light particulates on 2x4 tiles

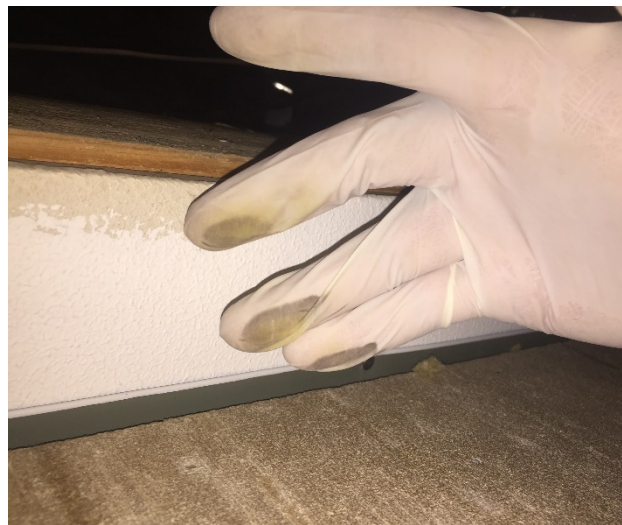
Attic space showing particulate on ceiling tiles.

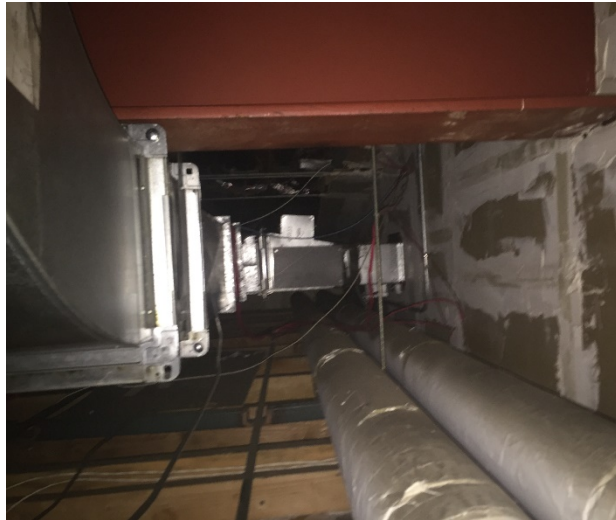
Condition inside attic space with HVAC components

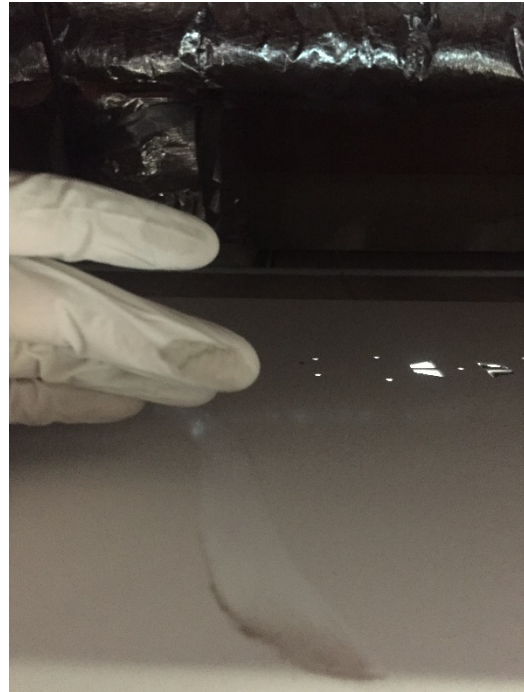
Particulate residue found on attic side of light fixture

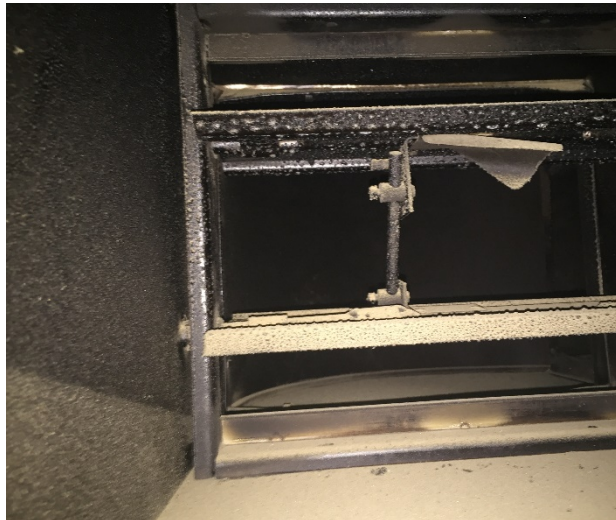
HVAC duct in source room

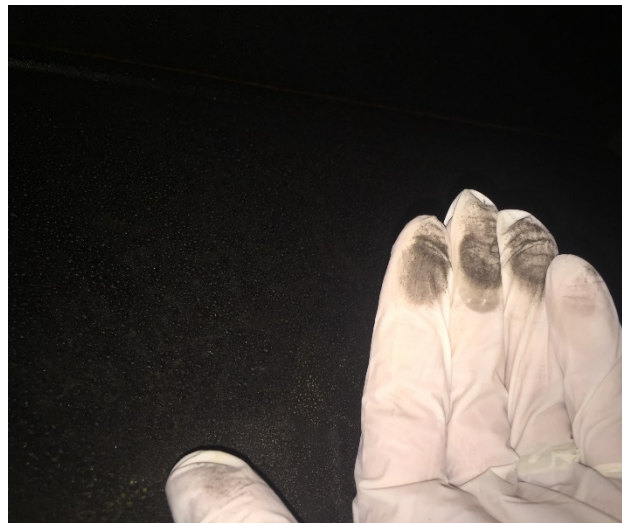
Heavy soot found inside HVAC duct in source room.

As it relates to restoration, soot particles tend to stick or magnetize to metal ducting, registers and components. PEC is unclear on how the current HVAC system is configured within the impacted areas. Apparently the HVAC system has been evaluated by an independent contractor and therefore it may be necessary to coordinate with this contractor to strategize the cleaning and restoration efforts.
